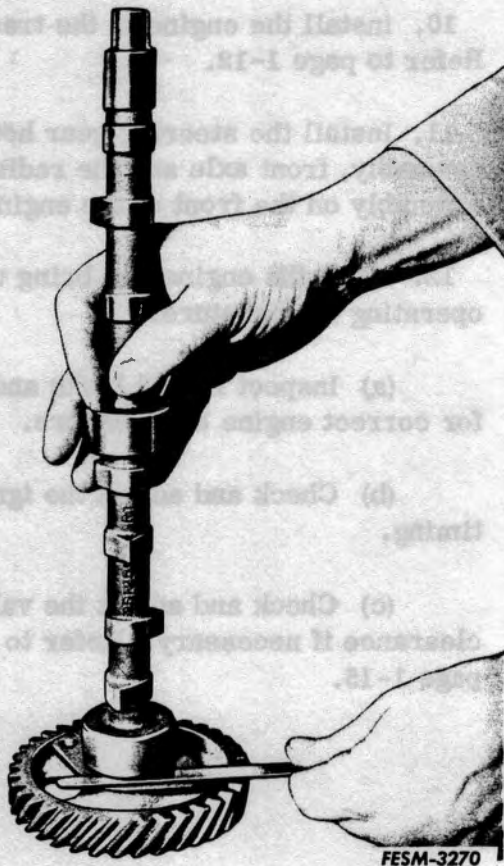
3. Check the crankcase bearing bore inside diameters. The specified ID is 1.8740 to 1.8755 inches for the front, 1.7490 to 1.7505 inches for the center and .8740 to .8755 inch for the rear.

4. Inspect the camshaft lobes for excessive wear, chipping, scoring and replace if necessary. If the lifting areas of the cam lobes, when compared with new camshaft, show amount of wear exceeding .020 inch, the camshaft must be replaced. If a new camshaft is not available for comparison, the cam lobe wear can be measured with a micrometer in the following manner. Take a reading across A-C and deduct the reading B-D; this will give the lobe lift. When the cam lobe wear limit has been reached, this lift will be .020 in. less than the specified lift of .232 inch. The camshaft must then be replaced with a new one.
