## Float Assembly

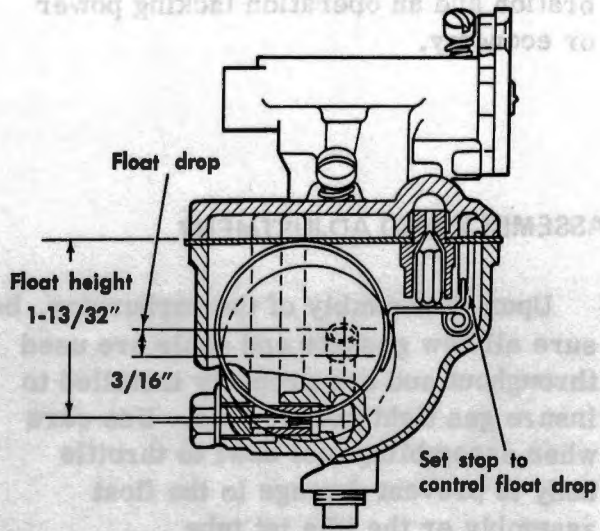
Replace the float assembly if float is loaded with fuel or if the float lever axle bearing is worn excessively. Inspect top side of the float lever for wear where it

contacts the fuel needle valve.

The float axle should be replaced if any wear can be detected on its bearing surfaces.

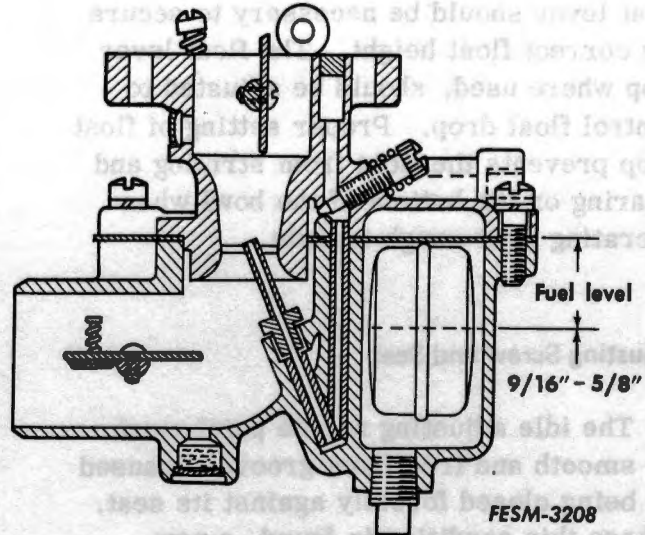
| 1. Throttle body | 4. Float axle support |
| 2. Fuel valve seat | 5. Float |
| 3. Fuel valve | 6. Float axle |
